Manhole Inspection Summary

Manhole # S31CC_038MH

Insp Date: 1/30/07 1:00 PM

Location Address: **890 LINDEN AVE**

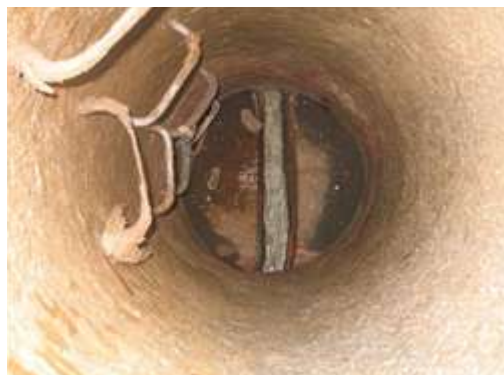
Top View

Corroded steps. Evidence of surcharge - Bench debris.

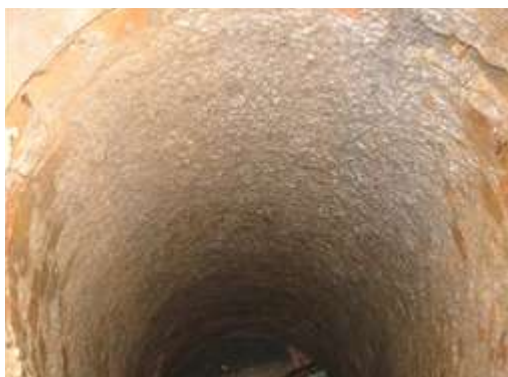
Defect

Frame leaks. Adjustment deterioration and infiltration. Corbel and Barrel infiltration.

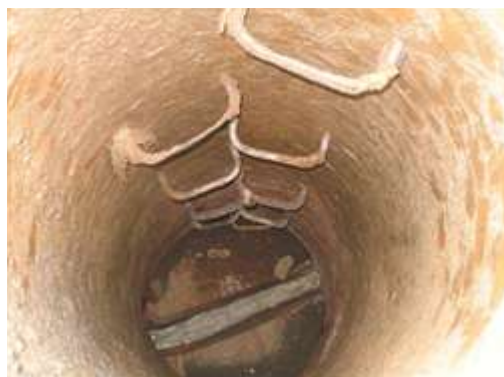
Defect

Evidence of surcharge - Bench debris. Corroded steps.

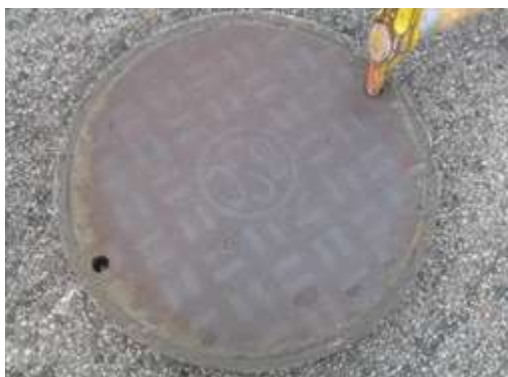
Defect

Worn cover.

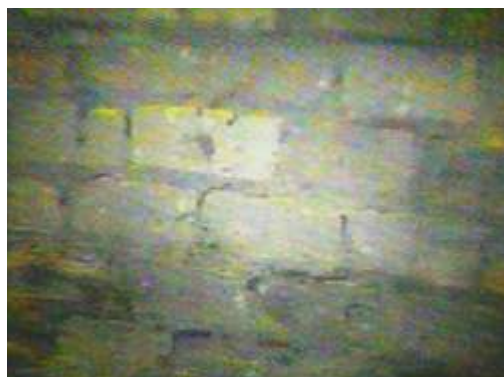
Defect

Barrel infiltration.

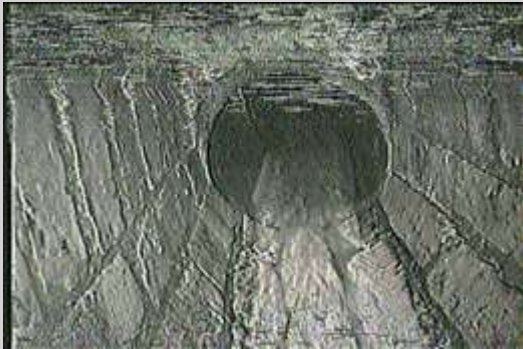
8 in. Circular Gravity Sewer Pipe Out @ 12 O'Clock

Infiltration: **Evidence** Pipe Seal Cond: **Unknown**

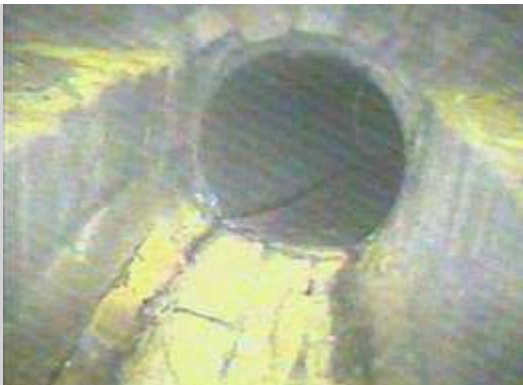
8 in. Circular Gravity Sewer Pipe In @ 6 O'Clock

Infiltration: **Evidence** Pipe Seal Cond: **Unknown**
